# Manhole Inspection Summary

Manhole # S15AA1026MH

Insp Date: **3/22/07 9:18 AM**

**Location** Address: **3634 PARK HEIGHTS AVE**

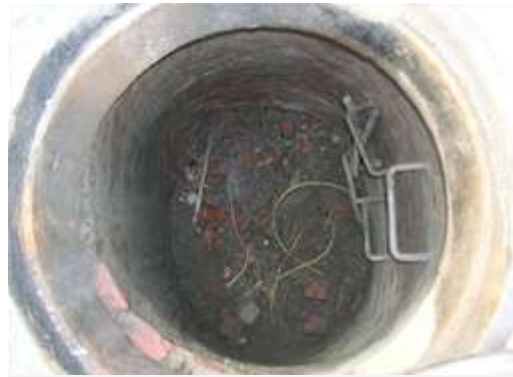
Top View

Channel debris.

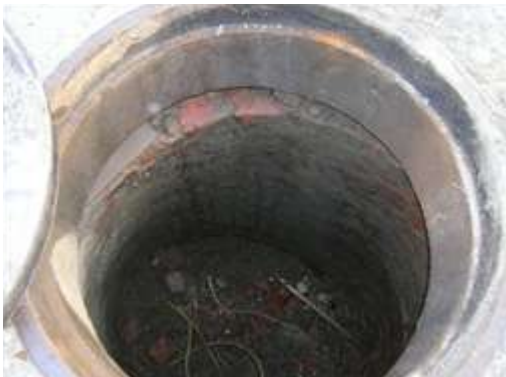
Defect

Frame leaks. Adjustment deterioration, loose brick and infiltration.

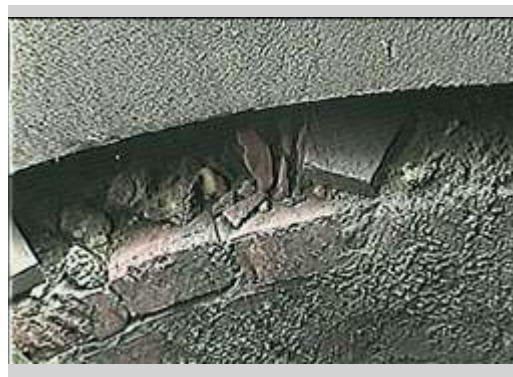
Defect

Frame leaks. Adjustment deterioration, loose brick and infiltration.

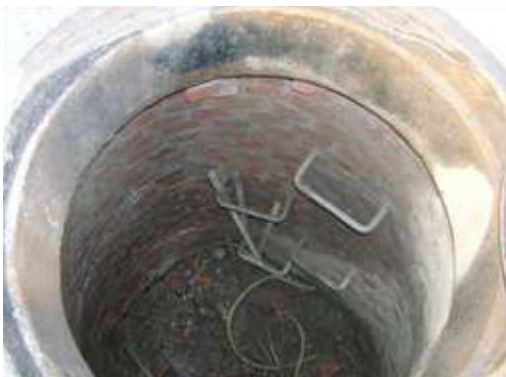
Defect

Frame leaks. Adjustment deterioration, loose brick and infiltration. Barrel infiltration - other side.

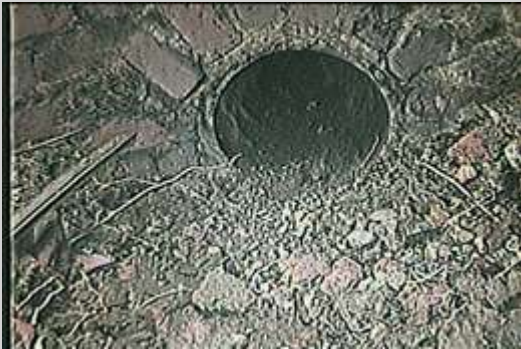
Pipe Out @ 12 O'Clock

Barrel deterioration and infiltration.
